Docket No. 217 - Development and Management Plan Inspection

Northeast Utilities Service Company Certificate of Environmental Compatibility and Public Need for the construction of a 345-kV electric transmission line and reconstruction of an existing 115-kV electric transmission line between Connecticut Light and Power Company's Plumtree Substation in Bethel, through the towns of Redding, Weston, and Wilton, and to the Norwalk Substation in Norwalk, Connecticut.

Date: January 4, 2006
Sandary 1, 2000

Location: 115 kV Underground Route

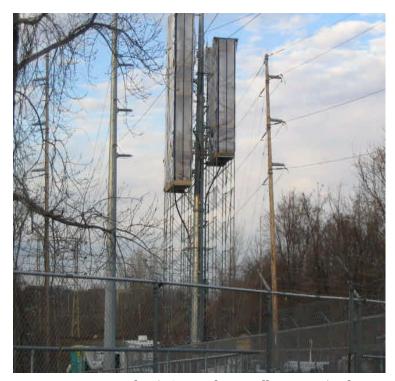
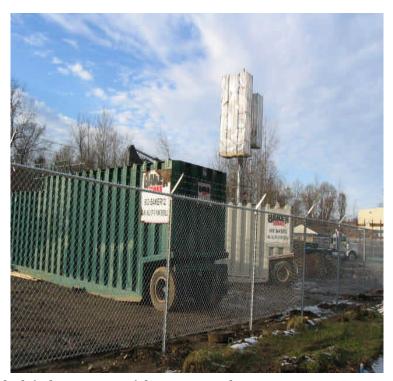
115kV (ROW and Norwalk Junction): Photo on the left shows a view of the structure adjacent to the Norwalk substation. Photo on the right shows a view of the structure at Norwalk Junction. Active work was ongoing and scaffolding and shrouds were present at both. 1/4/06

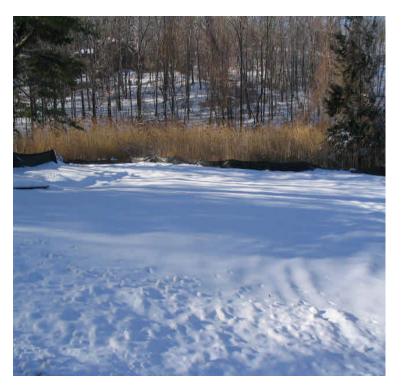
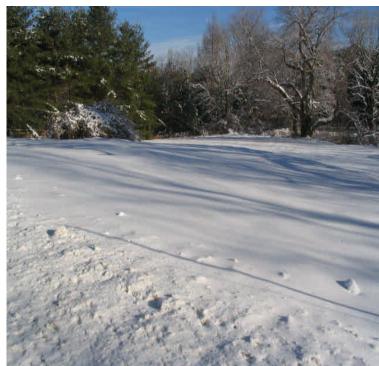
115kV (Rt. 107): Photo on the left shows the Redding Country Club storage area which has not been used for some time. Photo on the right shows the Rt. 107 turn storage area where snow cover has returned. Erosion controls are still necessary as a proactive measure. 1/4/06

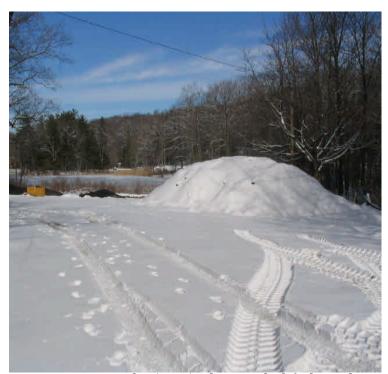
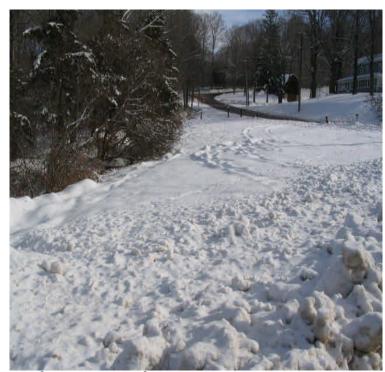
- A small stream crossing near Putnam Park at a vault also remains clear at this time. 11/23- 1/4/06	- Provide restoration in the spring if necessary. 1/4/06
Staging, Storage, and Parking Areas	- At the storage area off Rt. 58 near Putnam Park controls were pushed over by sediment laden snow plow piles in some locations. 12/14-1/4/06	-Snow needs to be pulled back and erosion controls repaired. Retain the silt fence here due to the proximity of the pond. 12/14-1/4/06

115kV (Rt.58). Photo on the left shows the Putman Park storage area with snow cover. Previous snow plow issues over the silt fence remain. Photo on the right shows a view of the Sunset Hill Rd. storage area. Erosion controls are still needed here as a proactive measure. 1/4/06

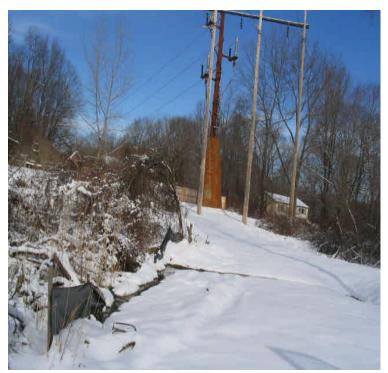
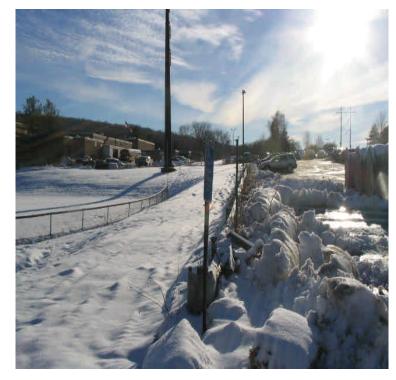
115kV (Hoyts Hill and Bethel Ed) Work is inactive at both locations. Some restoration will likely be necessary in the spring, especially to repair ruts along the ROW at the school. 1/4/06
